**Water Damage Investigation
Bell Residence
Pine Apple, Alabama**

**Travelers Insurance
Emerson, Georgia
Claim No. L5K6586**

**Professional Inspection Consultants, Inc.
Decatur, Alabama**

January 27, 2005

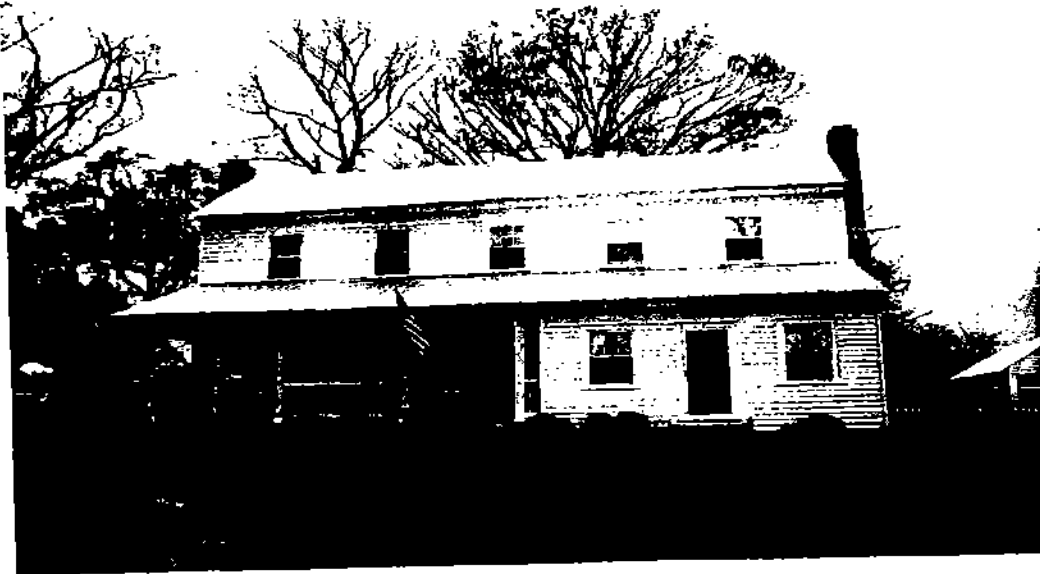
1. We noted wind damage to trees, out buildings, and fences in the vicinity of the house.
2. We noted damage to the metal roof above the 2nd floor at the rear right corner of the home and at the center of the 2nd story roof in the front where the metal roof was pulled up slightly.

1. We believe the lifted metal roof in from center and damage to the metal roof at the rear right corner to be related to the storm event. We noted roof leakage only from the damaged area at the rear right corner of the roof. This is evident from our inspection of the attic space in this area.

Picture No. 1 – Front view of Bell Residence. Notice raised metal roofing in center 2nd story.

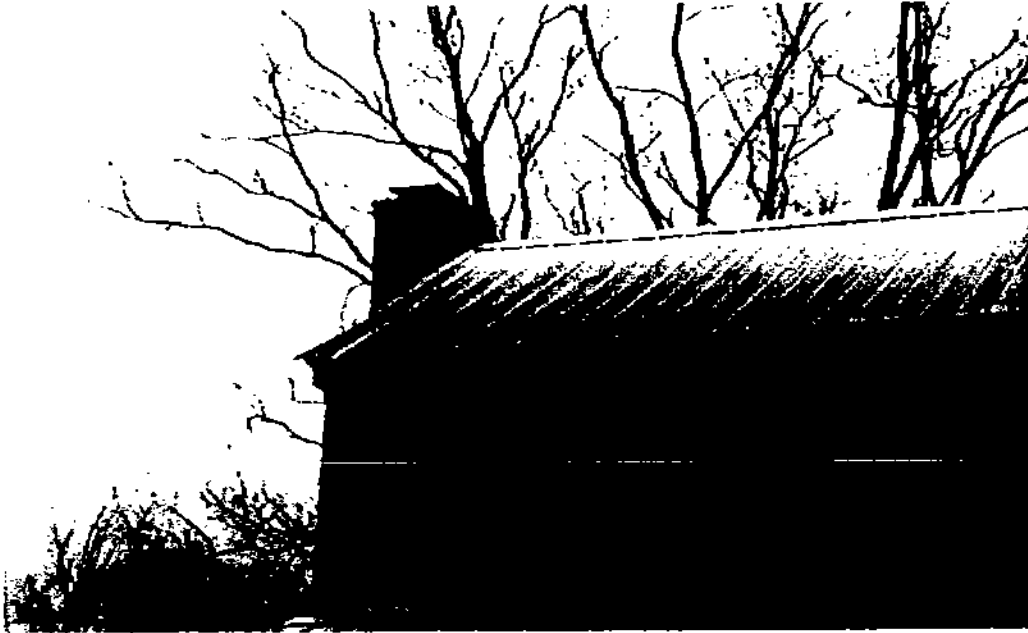
Picture No. 13 – Damaged roof, rear right corner.

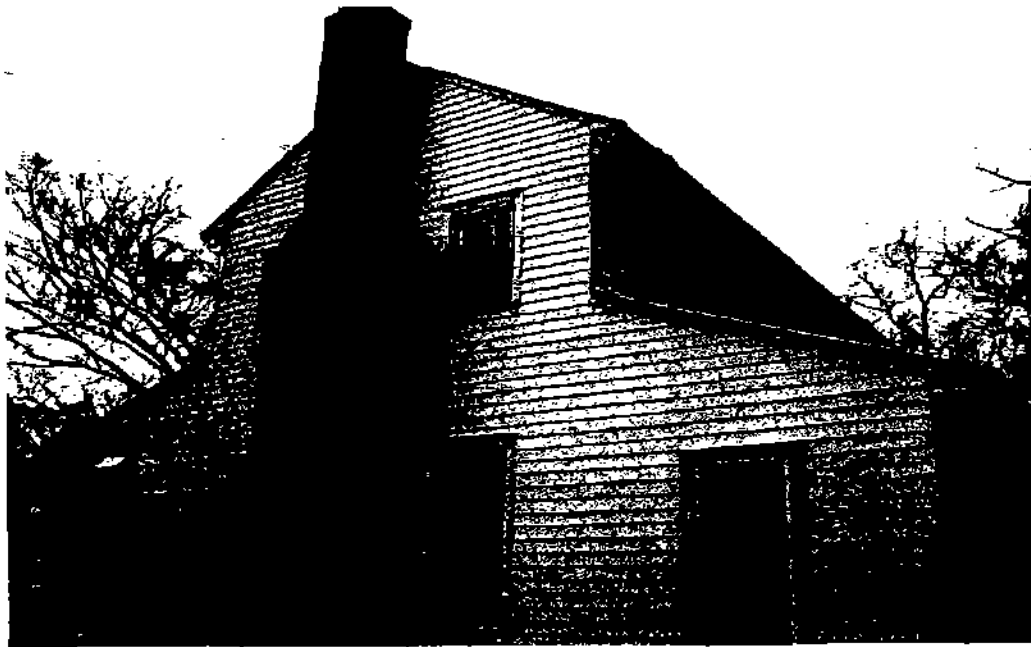
3. We did not note any pulled off siding or damage to the exterior walls. No movement to the chimneys was noted.
4. We inspected the crawl space of the home and noted that the home had been recently leveled. There were newer foundation block supports and floor joists in-place indicating recent repairs. The repairs appeared to be from one side to the other of the crawlspace.

Picture No. 14 – Area of recent roof damage. No damage to siding.
